**Häst, PSC**

**Large Animal Sling Support Bar Test**

**11/16/2004**

2004-1844

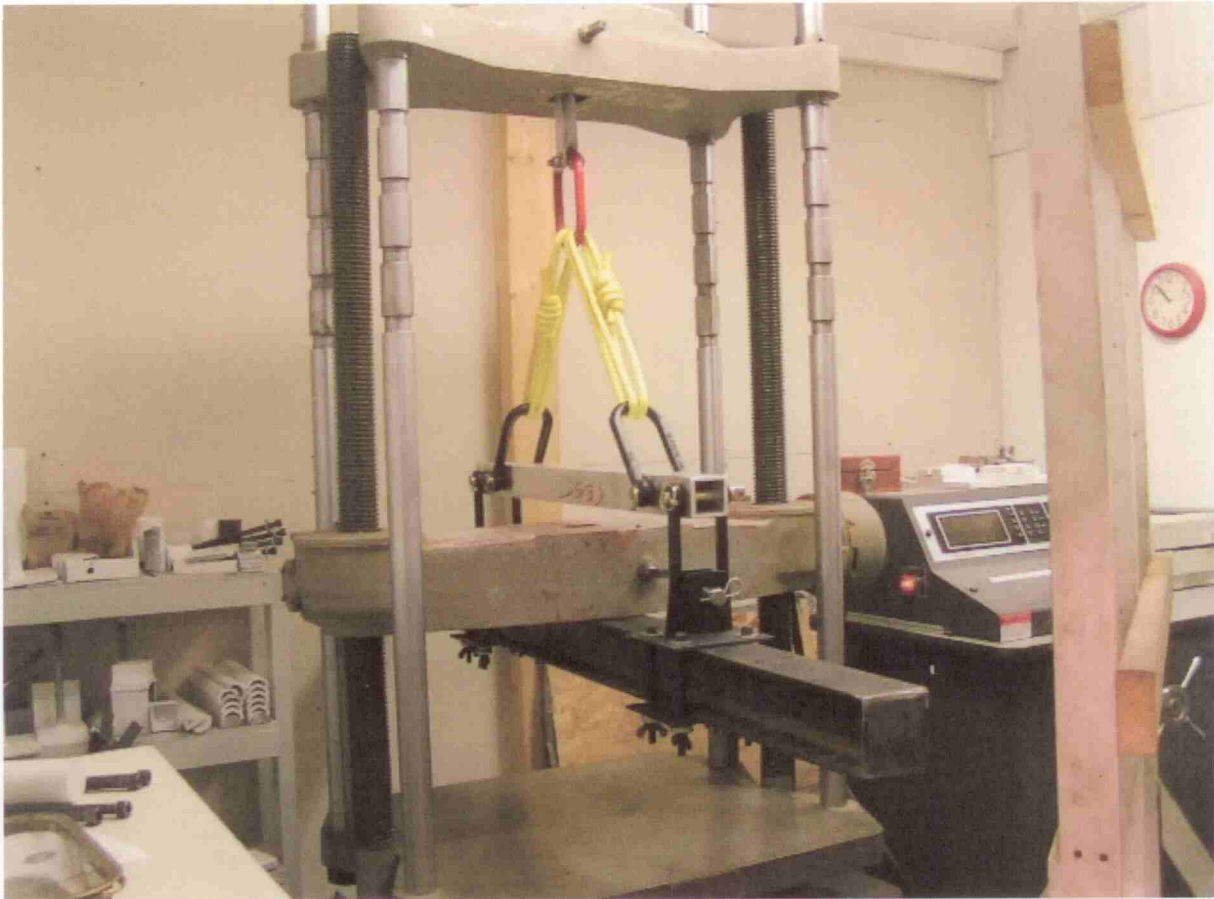
Test set up

The support bar was set in the Tinius Olsen hydraulic test machine between the top platen and the center platen to load the support bar in tension. See attached pictures for details.

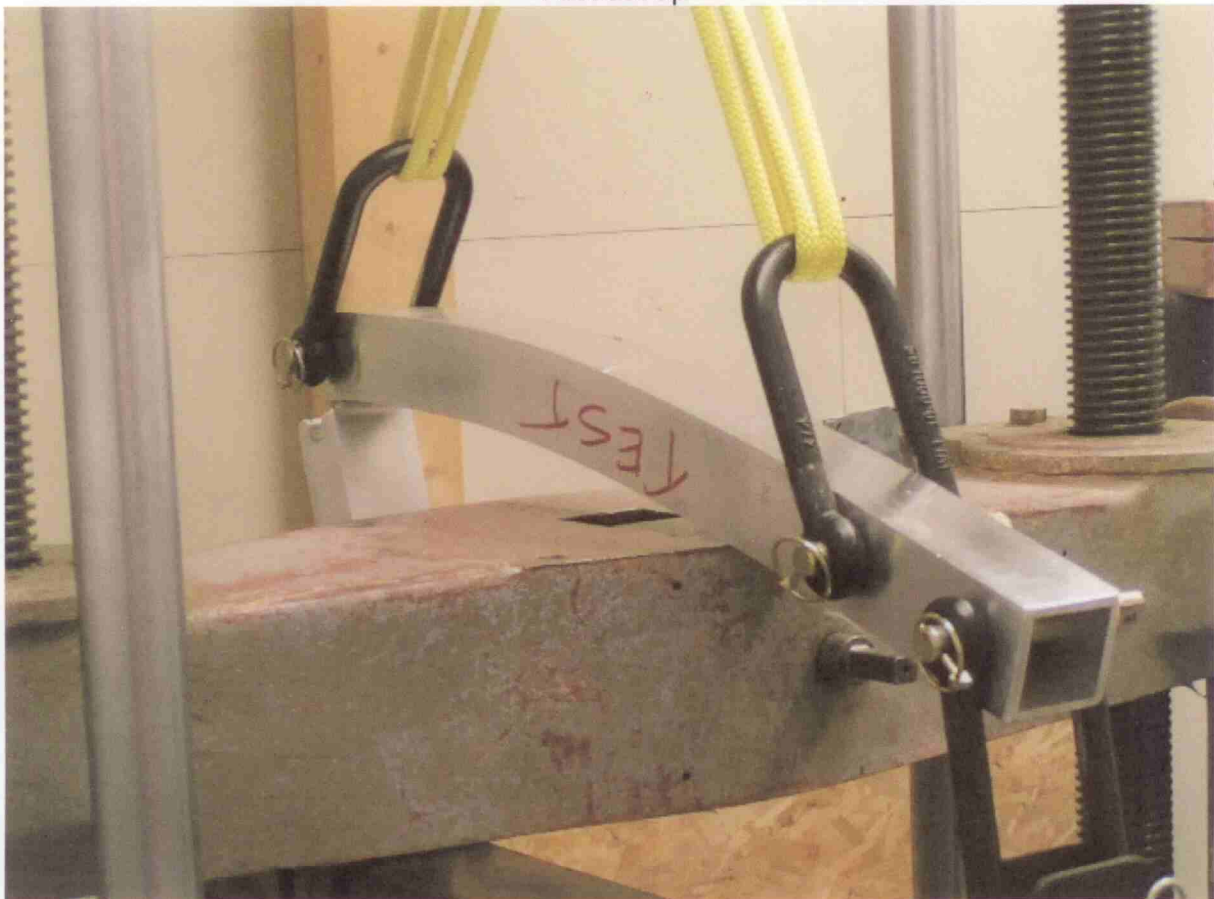
Sample at failure

<b>Sling Support Bar Test</b>		
<b>Run #1</b>	<b>Ultimate Load</b>	<b>Comments</b>
1	14,274 lbs.	A fixture bolt sheared before failure.
2	15,217 lbs	A hook on the fixture broke before failure
3	21,641 lbs.	The bar broke at a clevice location towards the end of the bar

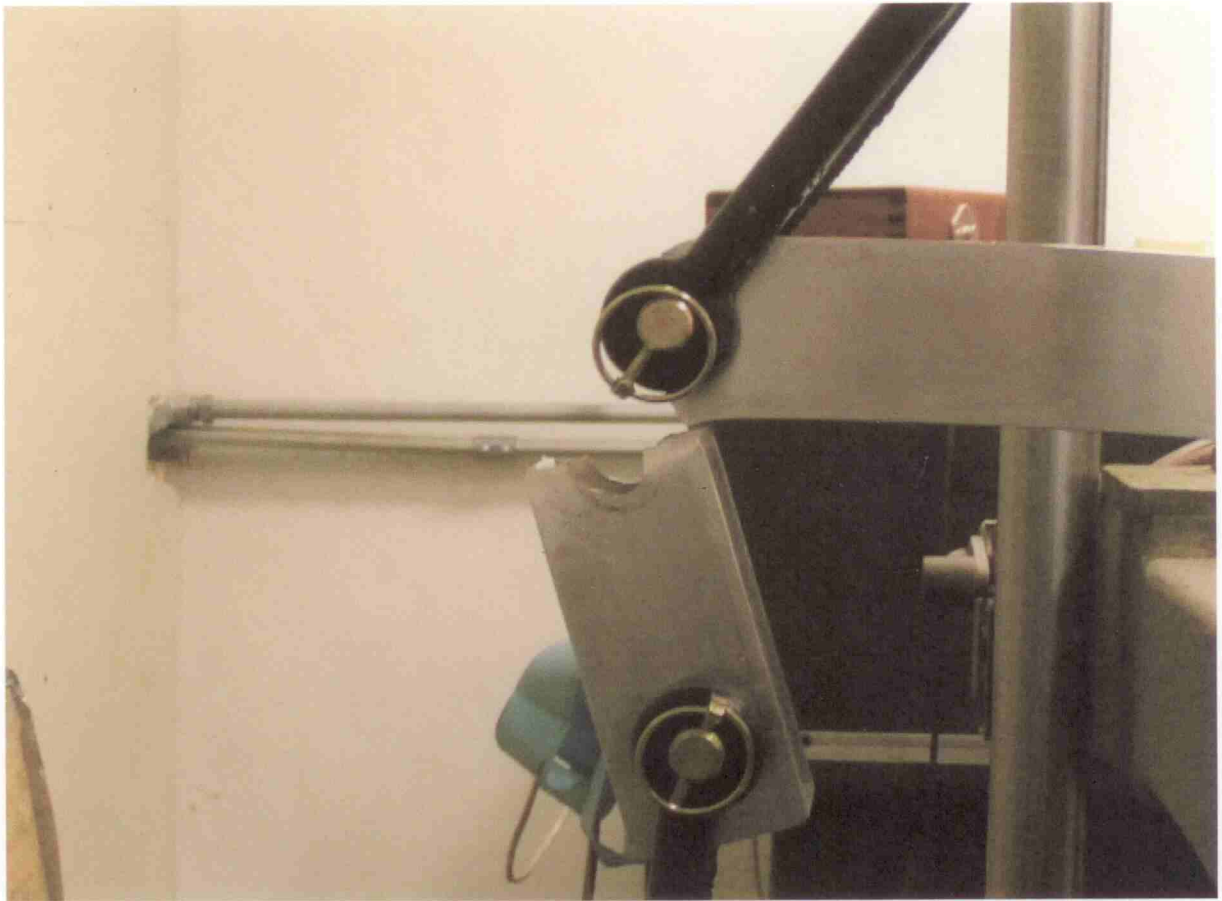
Sample at failure

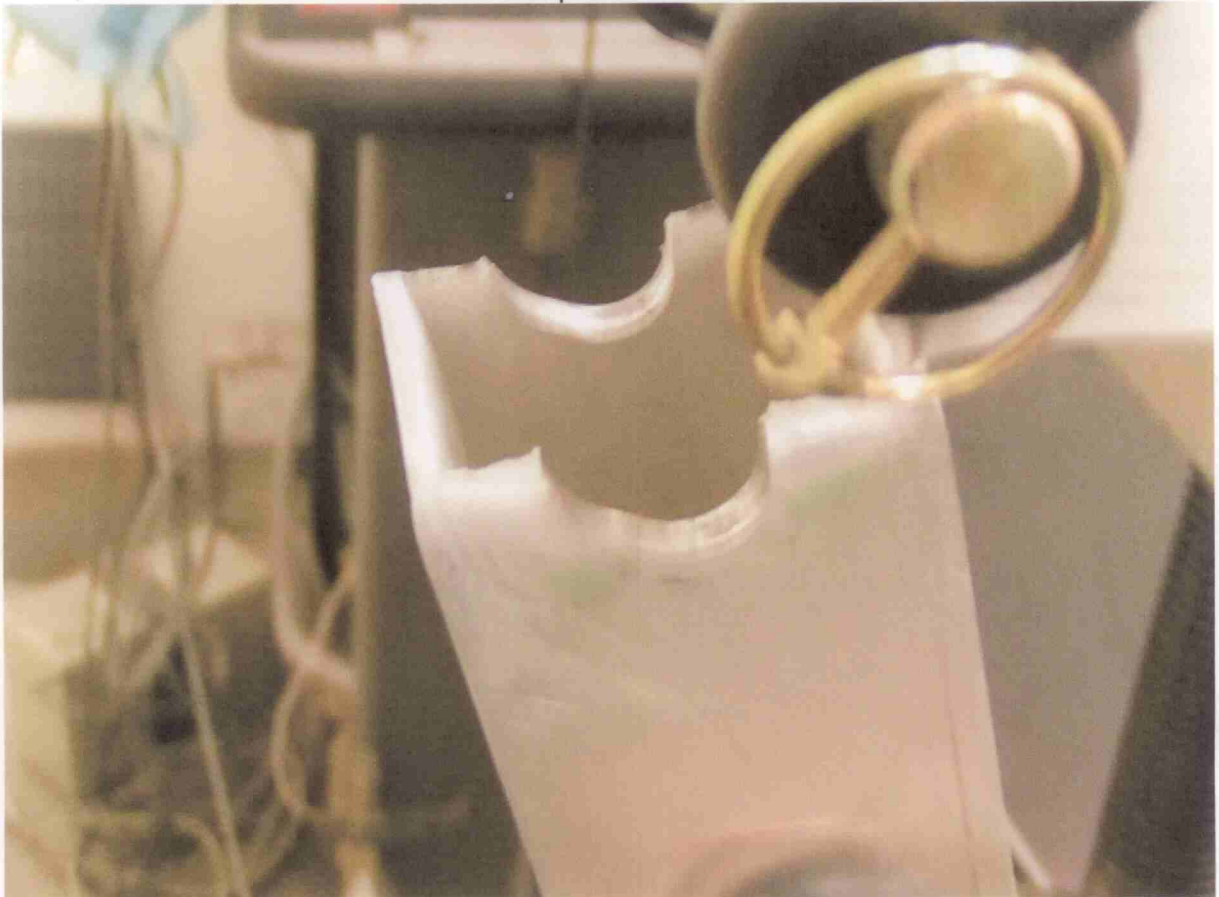
Sample at failure
